BLACKSTONE RIVER BASIN
GRAFTON, MASSACHUSETTS

FISHERVILLE POND DAM
MA 00577

PHASE I INSPECTION REPORT NATIONAL DAM INSPECTION PROGRAM

OCTOBER 1978

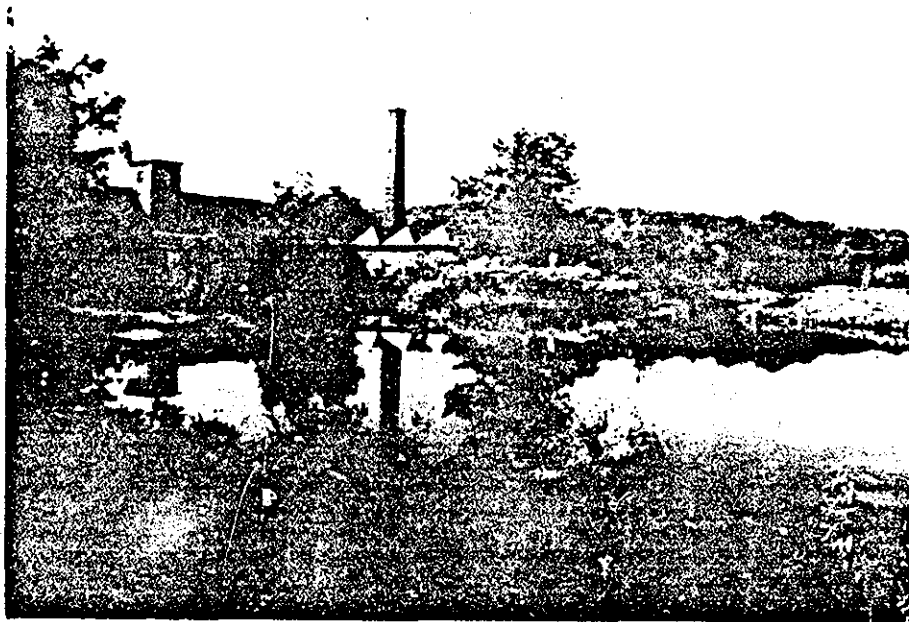
VIEW OF DAM FROM UPSTREAM OF EAST ABUTMENT

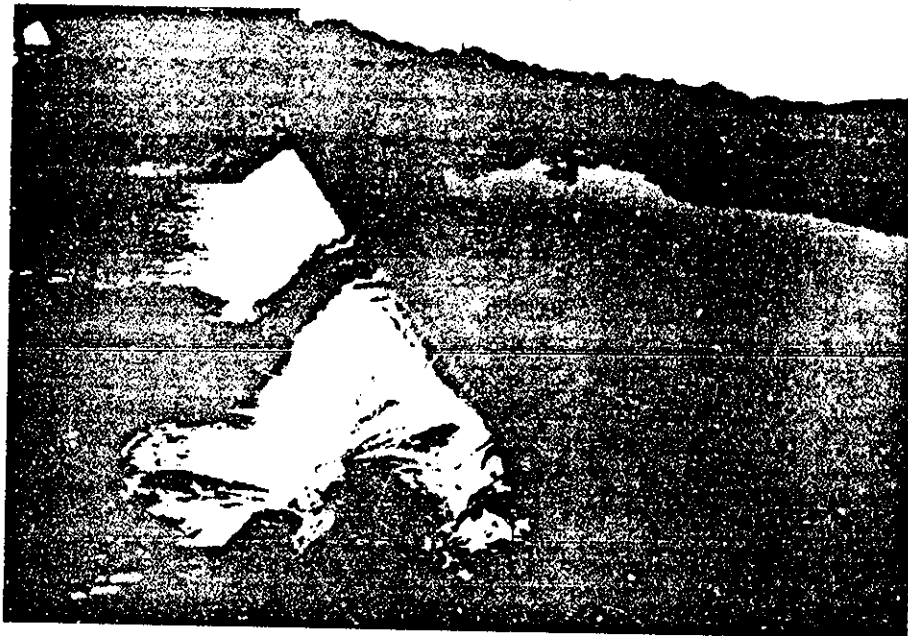
The stepped stone masonry spillway is in good to fair condition; some of the mortar on the two sidewalls is cracked or missing. The east end of the spillway is 0.1 foot lower than the west end. At the time of the inspection, the water level in the reservoir was almost 0.2 feet above the crest of the spillway. Therefore, most of the spillway was not visible.

NO. 1 VIEW OF SPILLWAY

- (7) clear all debris from the outlet channel
- (8) repair the cracked or missing mortar on the spillway and outlet training walls
- (9) remove all brush and vegetation from the spillway east training wall

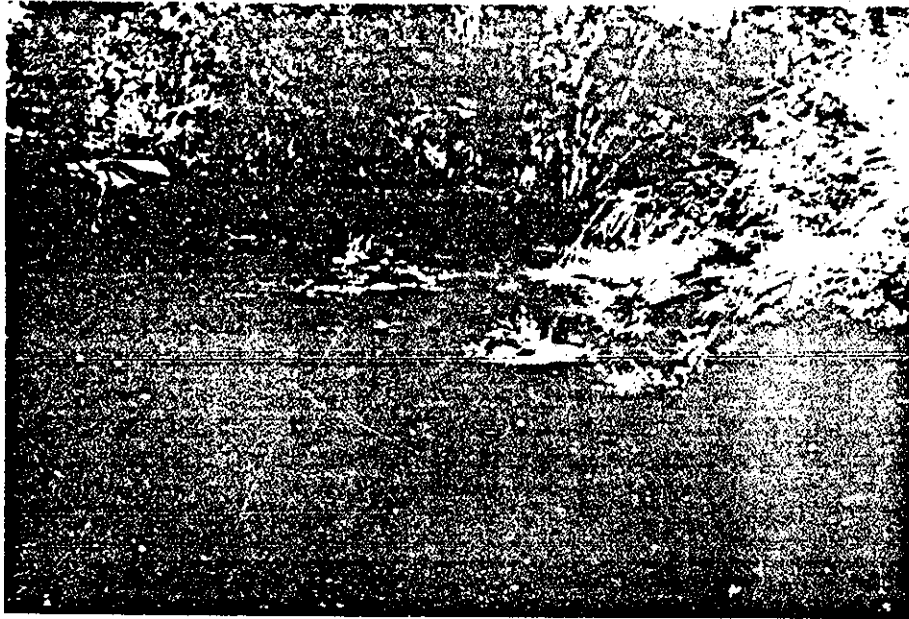
- b. Dam. In general, the dam is in fair condition. A narrow pool of dark stagnant water about 130 feet long at the downstream toe of the dam extends into a downstream semi-swamp area and indicates seepage through or underneath the dam. Surface runoff from the crest appears to be eroding the upstream and downstream faces, particularly, near the west training wall of the spillway. The west half of the downstream face is partially eroded. Both slopes and the crest are covered with brush, trees and scattered debris, including a wood platform and telephone pole. In addition, a large animal burrow about 1 foot in diameter and at least 3 feet deep was observed. There is no riprap protection on the upstream slope except for a few pieces of stone just west of the spillway.

Unusual Embankment or Downstream Seepage	40' to 170' West of spillway @ D/S toe water ponding
Piping or Boils	None visible.
Foundation Drainage Features	None visible.
Toe Drains	None visible.
Instrumentation System	2 - Obs. Wells

NO. 3 VIEW OF SEEPAGE AT TOE OF DAM

- a. evaluate the stability of the dam
- b. evaluate the seepage at the downstream toe of the dam
- c. conduct a more detailed hydrologic and hydraulic investigation of the site to design an adequate spillway and/or to increase the storage/discharge facilities at the site. The study should include the effect of downstream conditions.

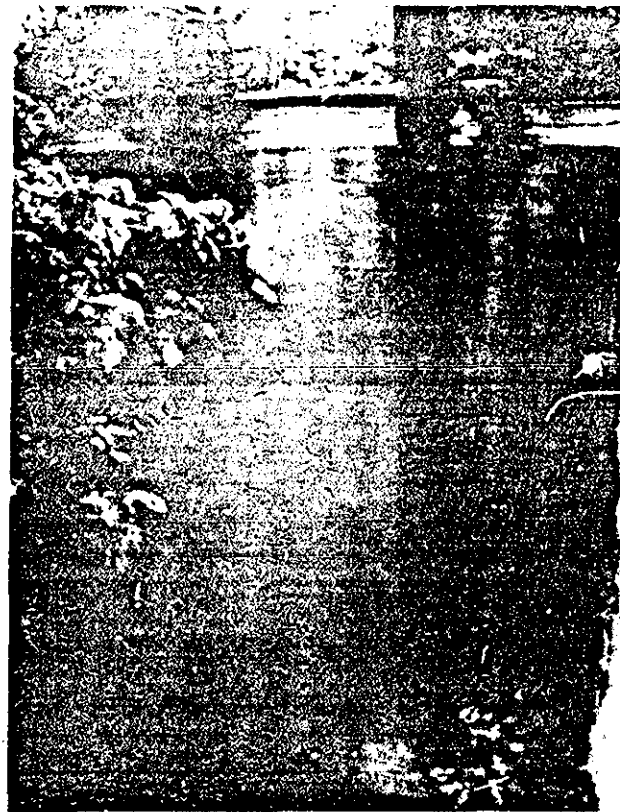
- j. Regulating Outlets. The low level outlet at the dam is a 6-foot by 6-foot slide gate located at the east end of the spillway. The outlet has a capacity of 300 cfs (2.2 cfs per square mile). This gate reportedly is used every spring and fall. A second outlet consists of six wooden slide gates in the Black-stone Canal diversion structure. Since the six handwheel operating mechanisms are rusted, this outlet is inoperable.

**NO. 5 VIEW OF HEADWALL AND OPERATING
MECHANISM OF OUTLET WORKS**

- (1) repair the slide gate at the outlet structure to prevent leakage and deterioration
- (2) remove the debris clogging the inlet channels for the outlet, and provide a log boom and/or trash rack
- (3) add riprap on the upstream face of the dam

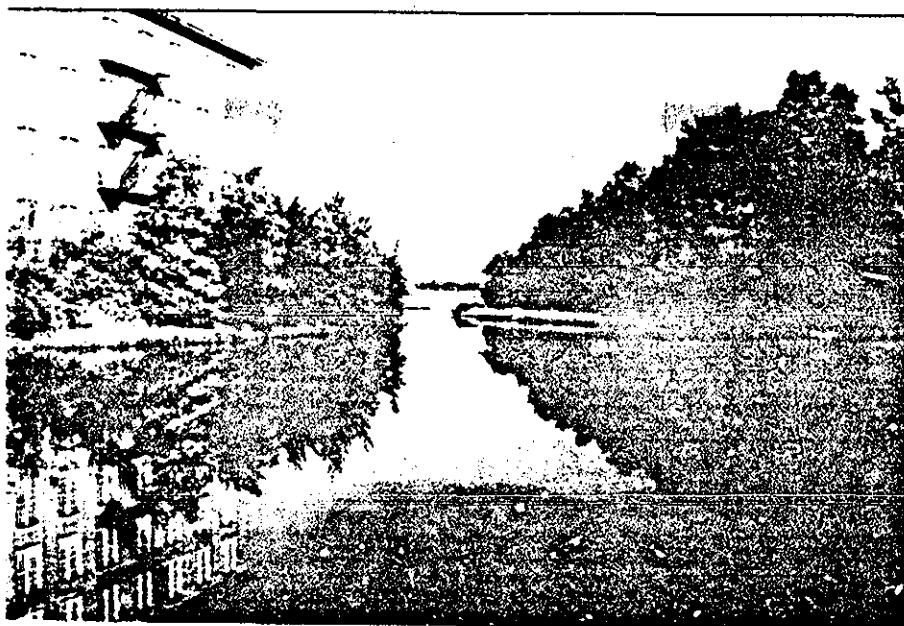
**NO. 7 VIEW OF BLACKSTONE RIVER
DOWNSTREAM OF SPILLWAY**

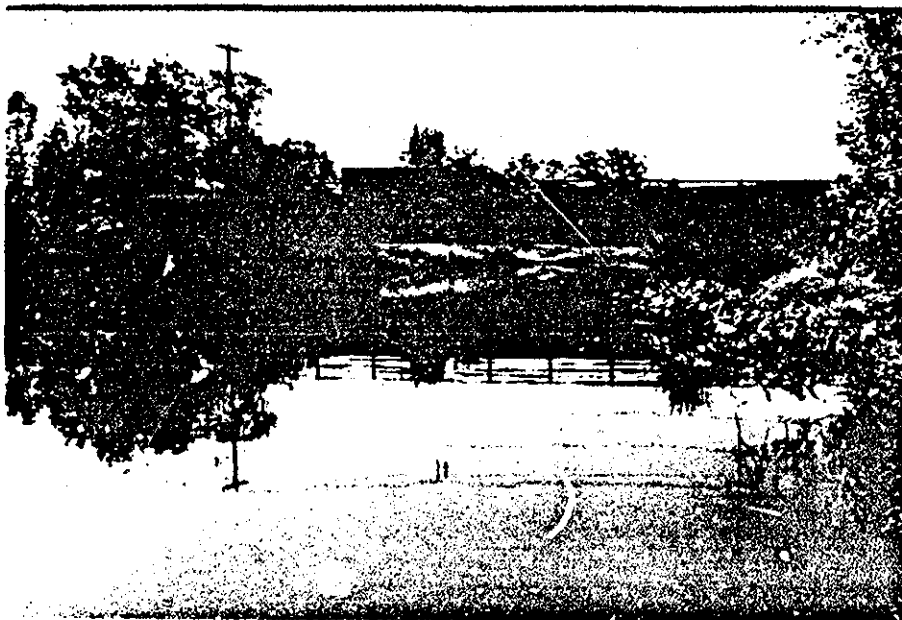
**NO. 8 VIEW OF MAIN STREET BRIDGE
OVER BLACKSTONE RIVER**
